## Mechanical Survey of the Conductive Glue Placement Sites on the Production Baseboards

**V 1.0**

August 23, 2002

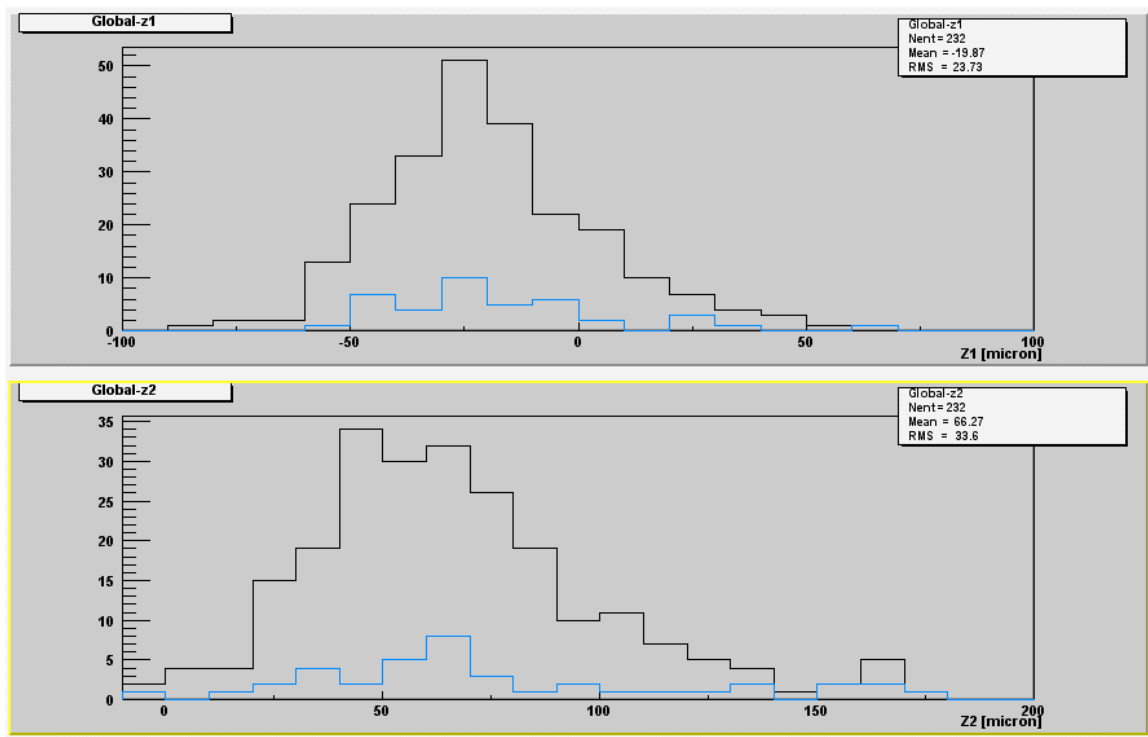
The histograms of all Z1 and Z2 measurements (Figure 2) do not reveal any gaps in the distributions. The average of Z1 is  $-20 \mu\text{m}$  and the average of Z2 is  $66 \mu\text{m}$ . Both distributions are rather wide, with long tails. The known spec on the depth of the site is  $30 \mu\text{m}$  [1].

The shape of the distribution does not change significantly when plotted for the baseboards with missing epoxy (Figure 2, blue histograms). This is due to

the fact that different sites depths are not correlated, so that the good 3 sites for a defective baseboard look normal. If we look at the bad site data only, then either front or the back side depth would be large (more that 100  $\mu\text{m}$ ), as shown in Table 2.

**Figure 2. Distributions of Z1 (top) and Z2 (bottom) for all sites and baseboards. The blue histograms display the data for the baseboards with missing glue in the vias.**

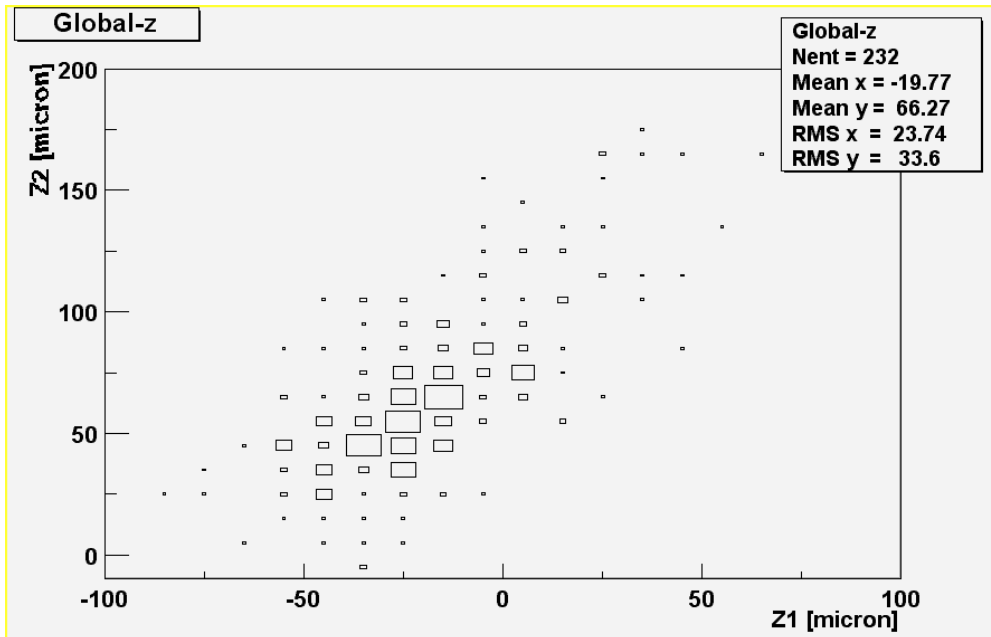
The Z1 and Z2 are correlated, as shown in Figure 3. For deep sites, the edges of the site are elevated with respect to its center, unlike the schematics in Figure 1.

Figure 3. Z2 versus Z1 for all sites and baseboards.

We noticed that the shape of the site is correlated with its depth.

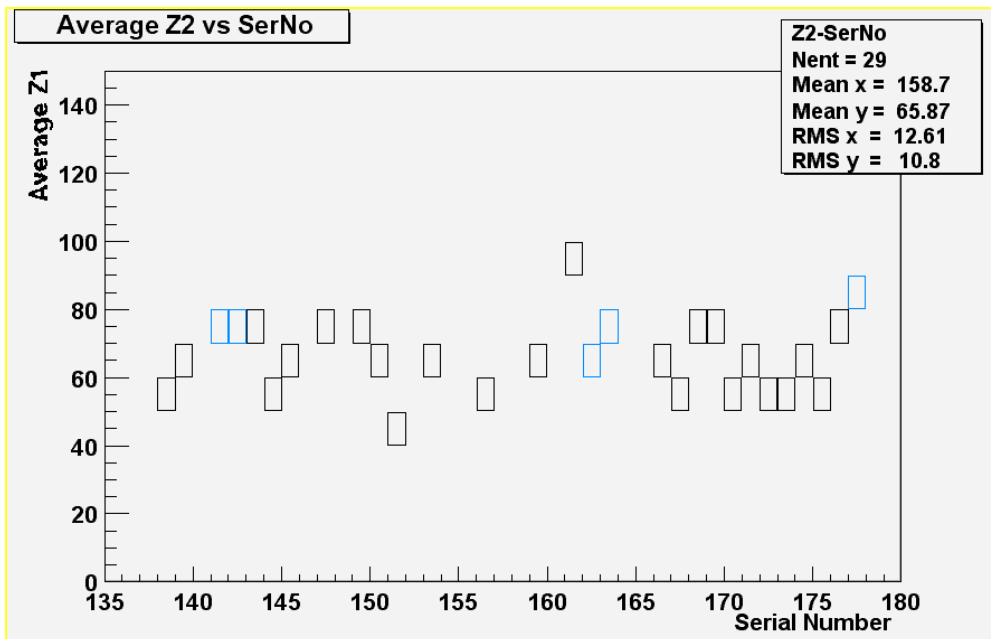
We do not see any obvious dependence of the site depth on the serial number, as shown in Figure 4.

Figure 4. Average Z1 versus serial number. Blue boxes indicate the baseboards with missing epoxy.

There does not seem to be any dependence of the defects on the baseboard serial number for our sample.
